NPDES Inspection Report

Permit # WAR05I001

Omak Forest Products, LLC

September 15, 2016

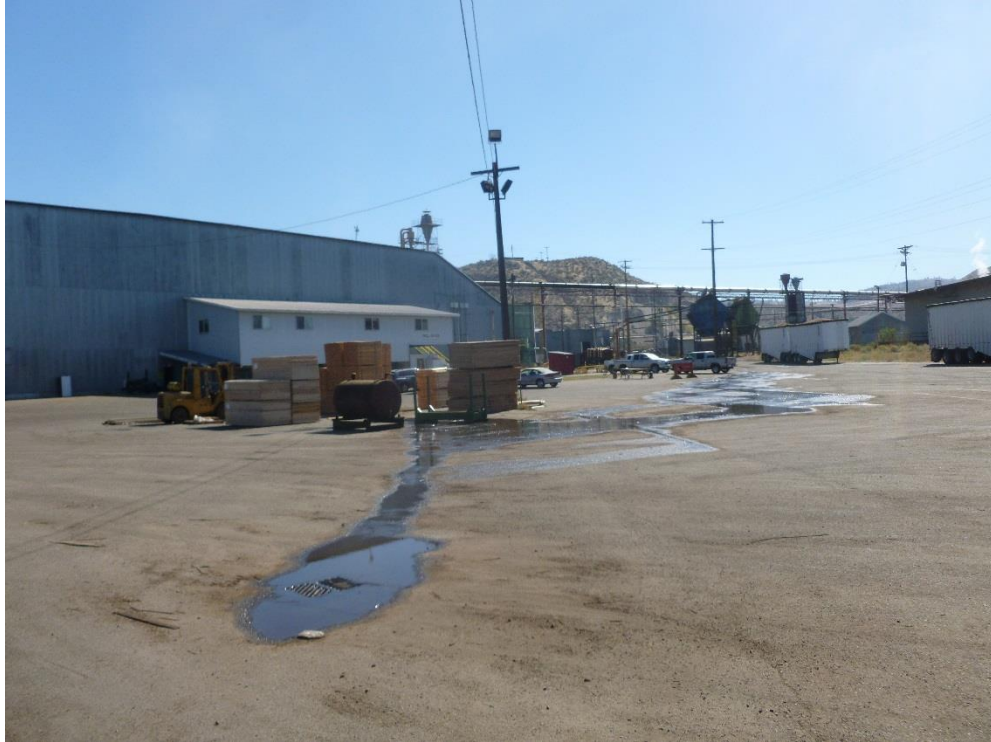
Outside the main office in the paved area southwest of the plywood plant, I inspected a catch basin that was receiving flow at the time of the inspection (**Photo 1**). Mr. Epperson attributed this flow to a leak in the tribal water distribution system. He said there were multiple water main leaks on the property. To the northeast of the plywood plant, I inspected another catch basin, which was surrounded by dirt and weeds (**Photo 2**). To the south of the plywood plant, Mr. Epperson showed me the approximate location of another catch basin, but the area was covered in woody debris (**Photo 3**) and the catch basin was not visible at the time of the inspection. It was unclear whether this catch basin had been officially plugged and decommissioned or whether the catch basin could be returned to use by removing the debris.

During the inspection, I also observed areas where potable water was leaking at the facility (**Photos 1 and 12**). Mr. Epperson said there were multiple leaks in the tribal water distribution system throughout the property. Although potable water is specified as an allowable non-stormwater discharge under Section 1.1.3.1 of the MSGP, I noted that these flows could commingle with contaminants or cause erosion at the facility.

Photo 1 / P1020739 – Easterly view of a catch basin receiving flow from a broken water main in the paved area southwest of the plywood plant

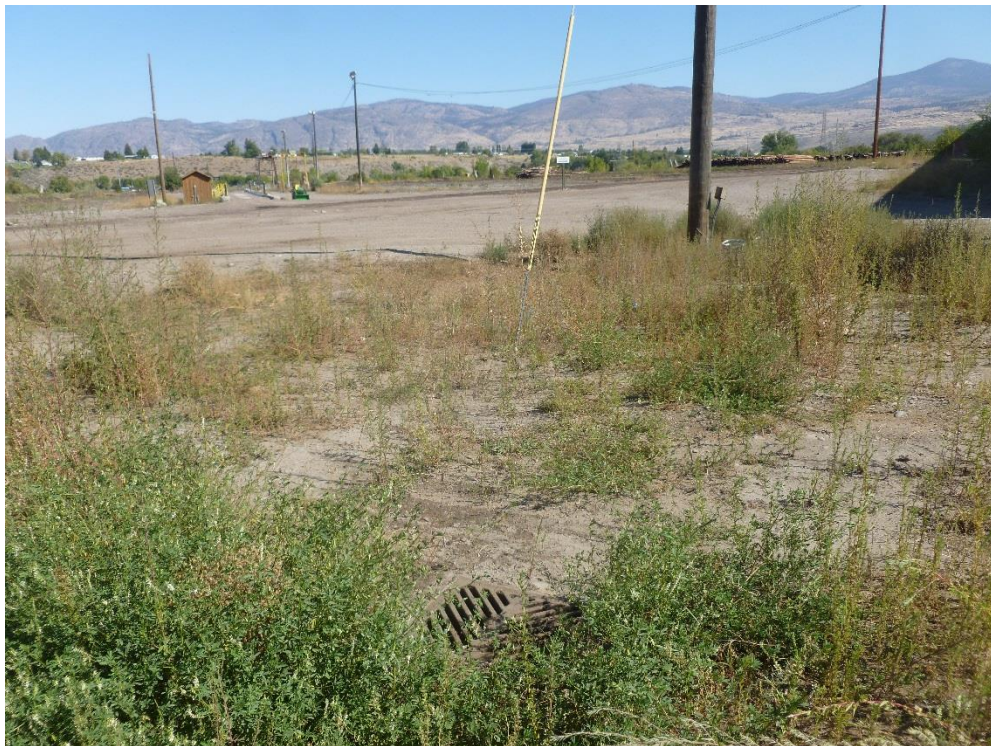
Photo 2 / P1020742 – Northerly view of the facility from the west corner of the plywood plant. A catch basin appears in the foreground.

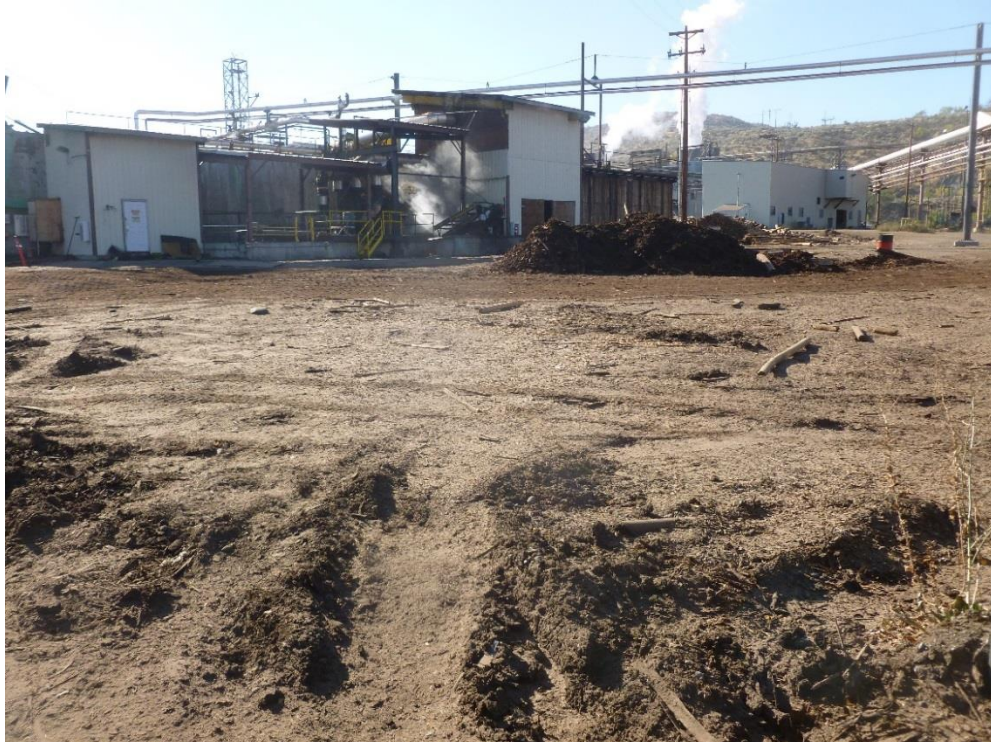
Photo 3 / P1020666 – Southeasterly view of the location of a buried catch basin. The log vat building and a pile of hog fuel appear in the background.

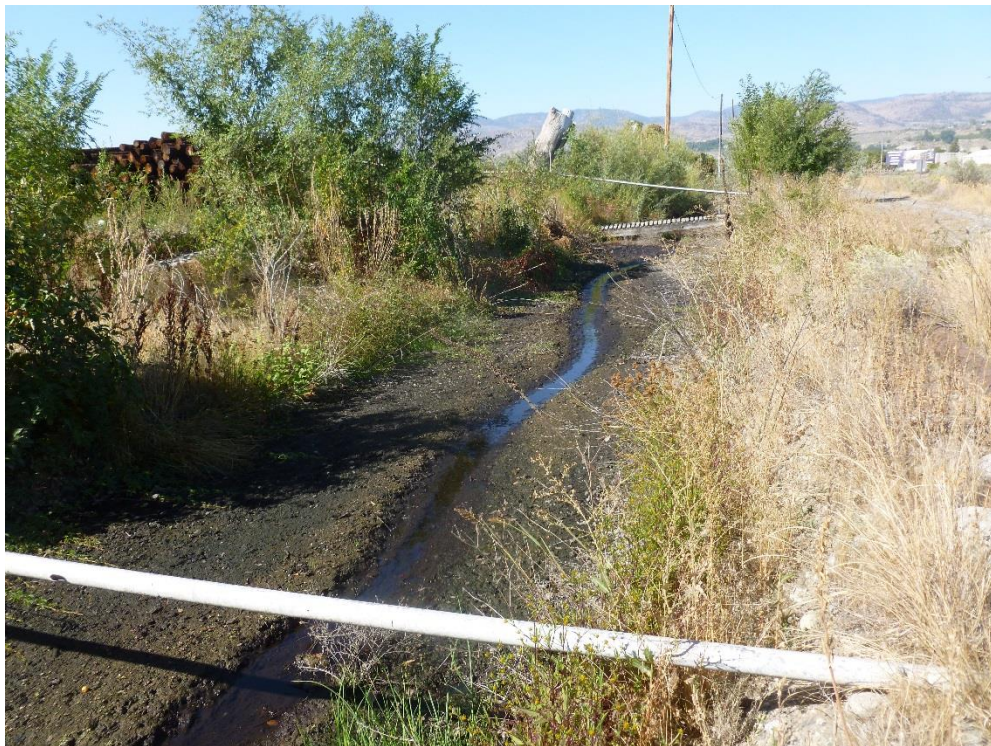
During the inspection, I noted that portions of the facility’s stormwater catchment pond were heavily loaded with sediment (**Photo 4**). Mr. Epperson said that OFP had been trying to get a company to come and remove the sediment for approximately one and a half months before the inspection. The concern is that the continued accumulation of sediment in the pond could increase the likelihood of an overflow and unplanned discharge from the facility.

Photo 4 / P1020732 – Westerly view of sediment accumulated in the catchment pond along the northern boundary of the facility

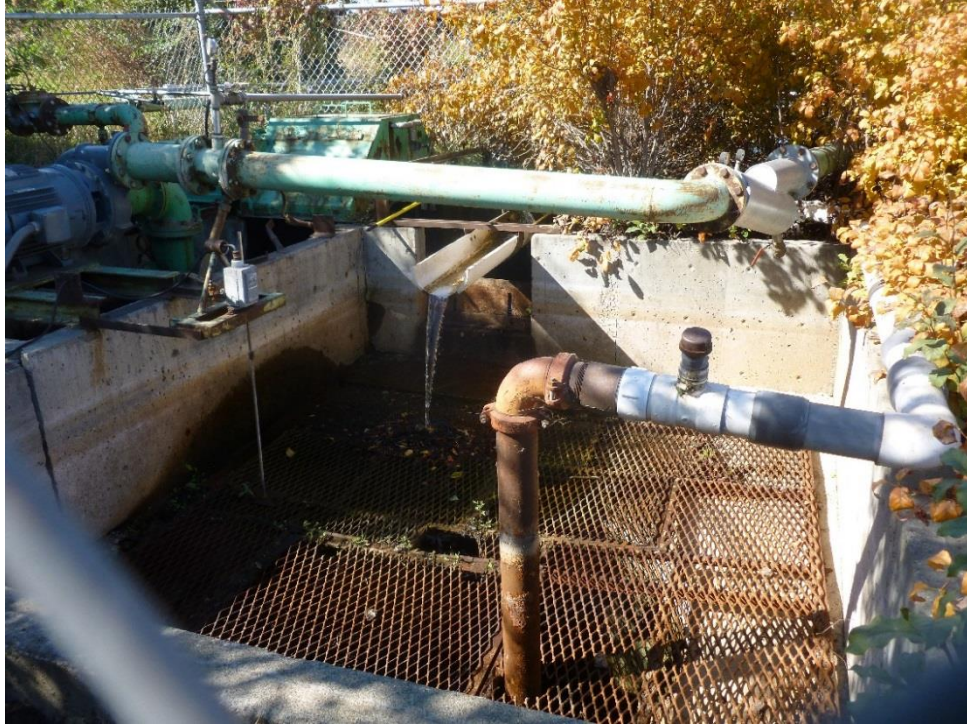
The catchment pond drains to a sump (**Photo 5**) in the northeast corner of the property. This flow is augmented by well water and sprayed onto the log piles (**Photo 6**) to keep the logs fresh.

Photo 5 / P1020728 – Sump located in the northeast corner of the facility at the east end of the catchment pond. The sump receives a combination of pumped well water and flow from the catchment pond for use in watering the log yard.

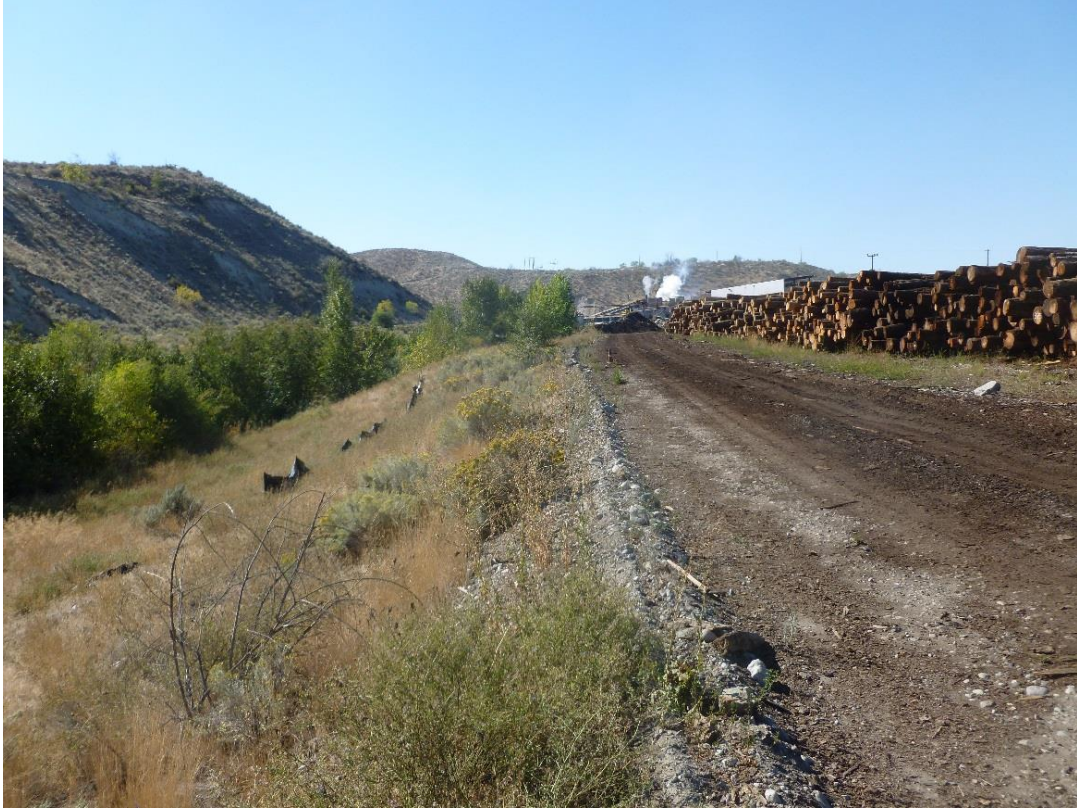
I inspected the northeast boundary of the property, where a dirt access road and small berm separated the log pile area from the vegetated bank of an unnamed creek (**Photo 7**). Midway down the slope of this vegetated bank, I observed a silt fence that was in need of maintenance (**Photo 7**). I asked why the silt fence was not located upslope closer to the berm to help contain stormwater onsite. Mr. Epperson said that environmental representatives of the tribe had recommended the location of the of the silt fence.

Photo 7 / P1020722 – Southerly view of the east side of the log yard. A small berm appears in the center along a dirt access road and silt fencing appears on the left along the bank of an unnamed creek.

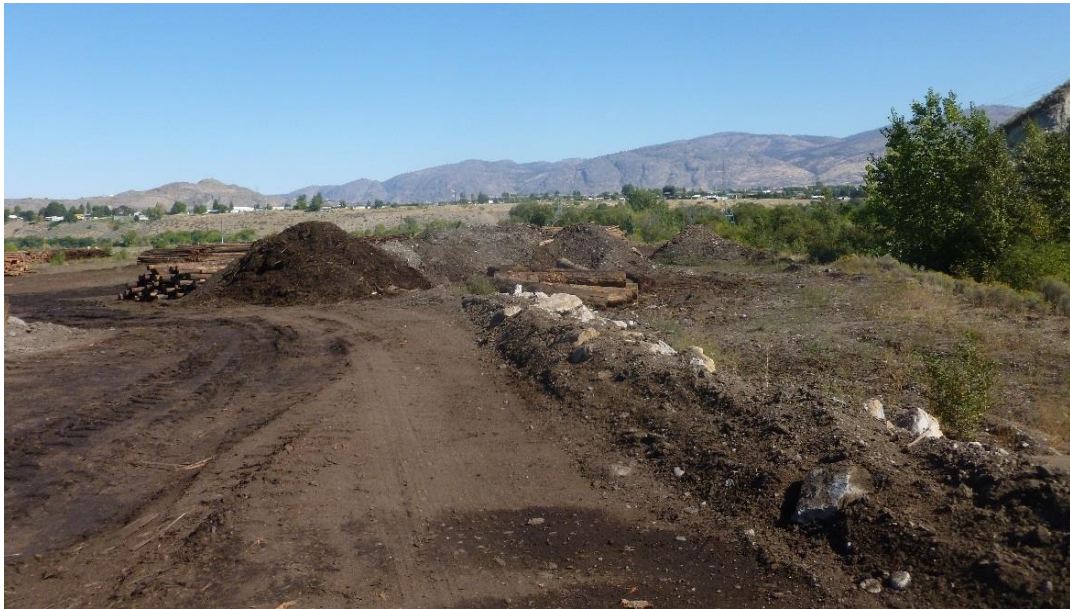
To the southeast of the log pile area, I observed piles of soil and woody debris (**Photo 8**) along the dirt access road above the creek. Near the southeast corner of the facility, I observed large piles of hog fuel abutting the west side of the dirt road (**Photo 9**). To the east of the log processing areas near the center of the facility, I saw that this dirt road formed an elevated barrier between the creek and heavy industrial activities at the facility (**Photo 10**).

During the inspection, I observed piles of soil (**Photo 8**) located above the unnamed creek along the eastern boundary of the property. I did not observe sediment control measures in this location. To the northeast of the plywood plant, I also inspected a catch basin, which was surrounded by dirt (**Photo 2**). I did not observe control measures in place to protect this catch basin from receiving sediment. I also noted that portions of the

Photo 8 / P1020719 – Northerly view of a pile of hog fuel (foreground) and soil piles (background) along the eastern boundary of the facility. The bank of the unnamed creek appears on the right. This is a cropped version of the original photograph.

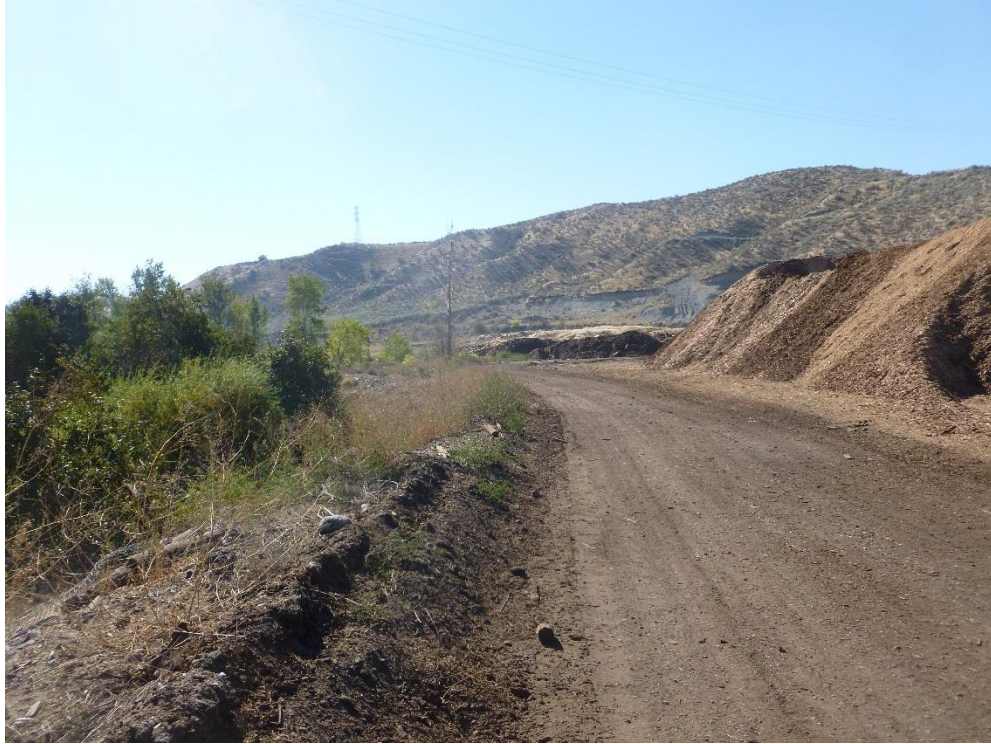
Photo 9 / P1020713 – Southerly view of the eastern boundary of the facility. Piles of hog fuel appear on the right and the vegetated bank of the unnamed creek appears on the left.

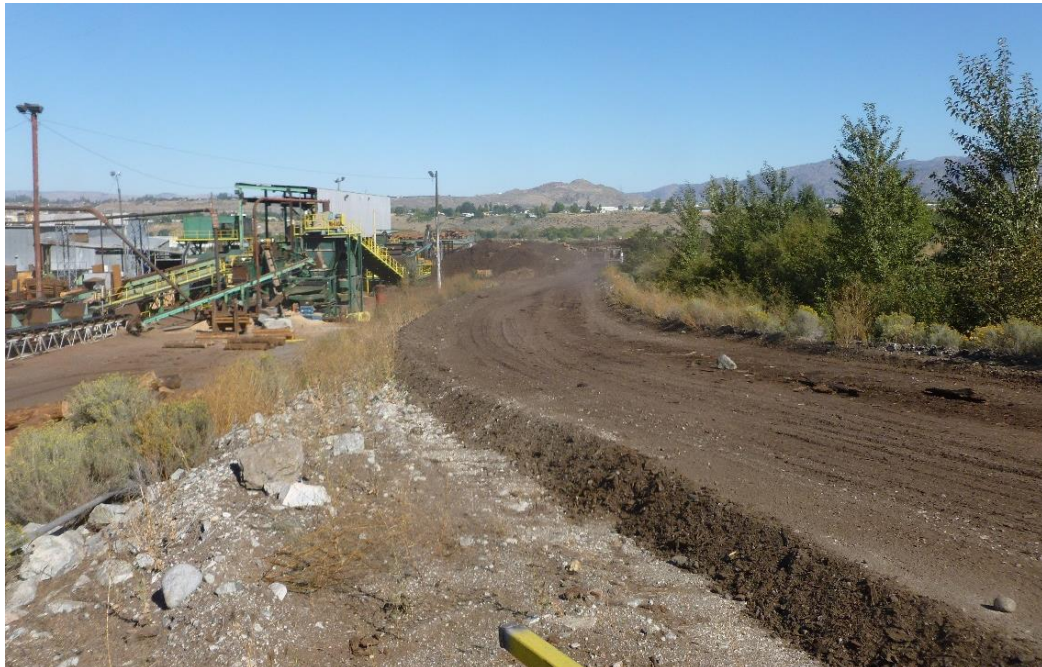
Photo 10 / P1020714 – Northerly view of the eastern boundary of the facility. On the dirt road in the distance, a small cloud of dust is visible behind a utility truck. The vegetated bank of the unnamed creek appears on the right. This is a cropped version of the original photograph.

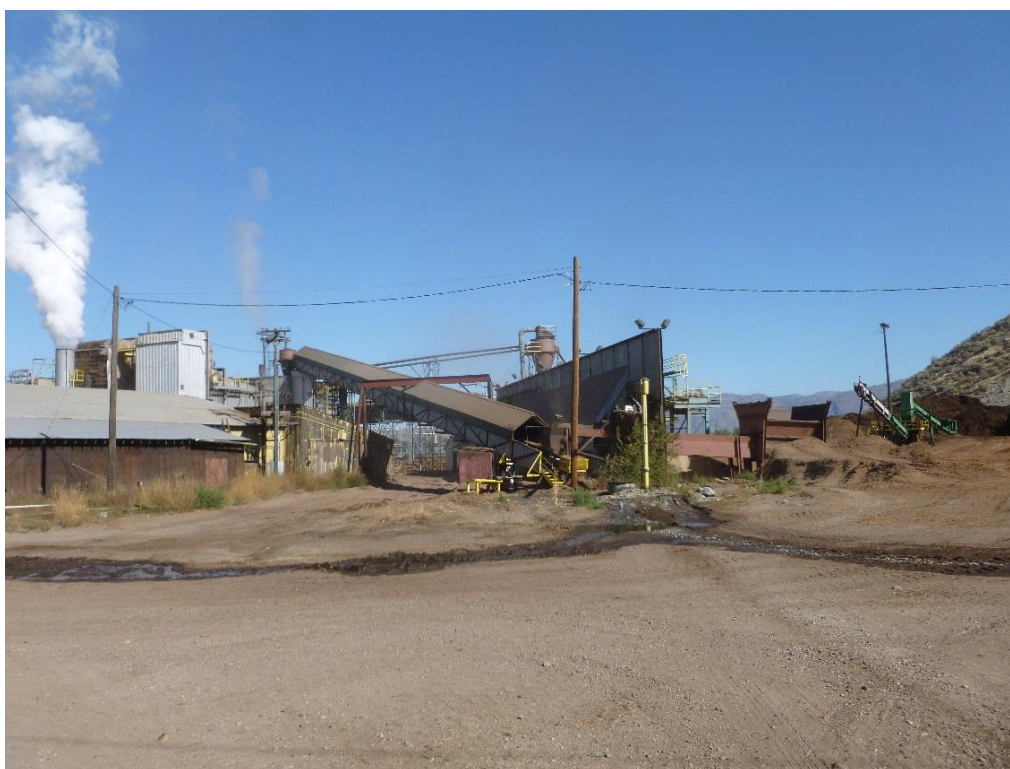
I inspected the hog fuel processing area and conveyor system (**Photo 11**), which is used to fuel the boiler. In the unpaved area south of the conveyor system, I observed pooling water from a leaking spigot (**Photo 12**). I also observed an open container of wet ash (**Photo 13**) scrubbed from the boiler exhaust. Mr. Epperson said this wet ash waste is taken to a nearby tribal solid waste landfill for disposal. South of the boiler, I observed an open dumpster and bags of salt stacked on the pavement (**Photo 14**).

Photo 12 / P1020698 – Northerly view of the hog fuel conveyor and leaking water spigot. Piles of hog fuel appear on the right.

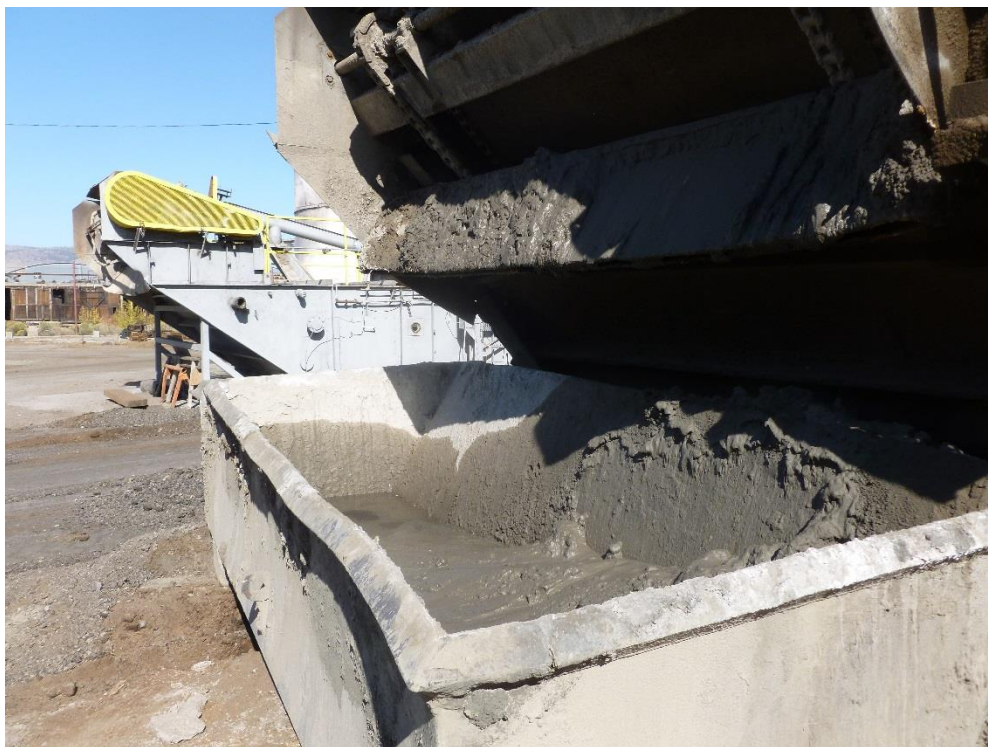
Photo 13 / P1020709 – Detail view of wet ash scrubbed from the boiler exhaust

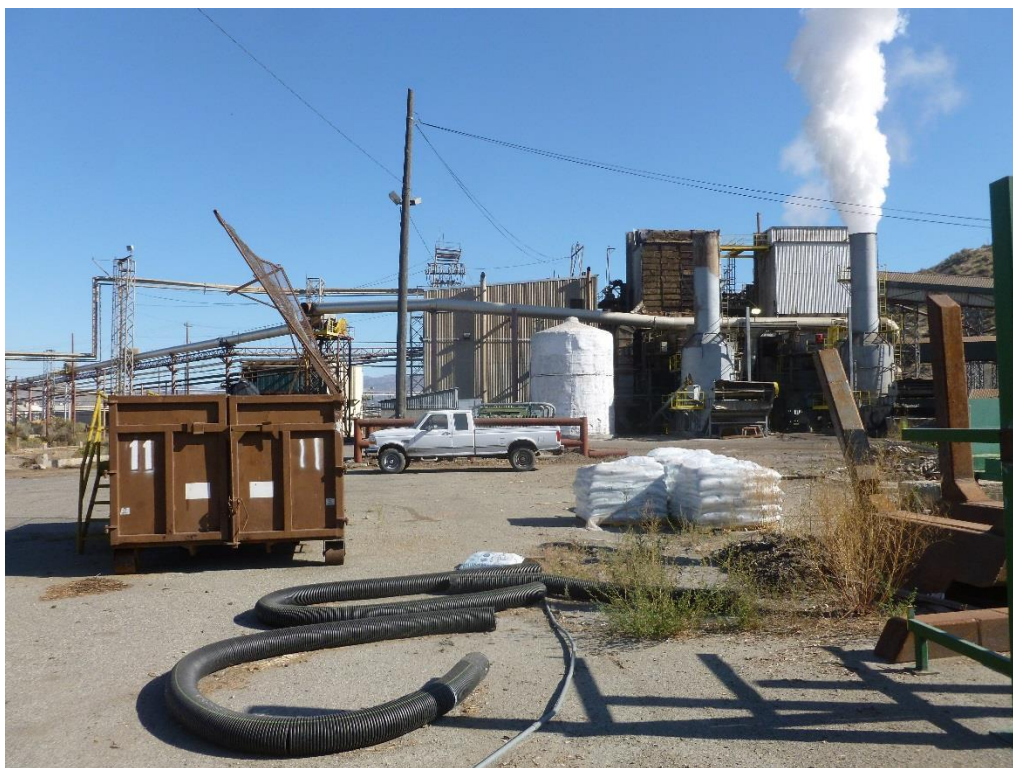
During the inspection, I observed multiple dumpsters (**Photos 14-16 and 30**) that were open and not in use.

To the south of the boiler, I observed bags of salt stacked on the pavement (**Photo 14**). On the south side of the log vat building, I observed bags of salt on the ground (**Photo 26**). During my review of the SWPPP, I did not see documentation of the location of salt storage areas at the facility.

Photo 14 / P1020692 – Northerly view of an open dumpster and bags of salt stored on the paved area on the south side of the boiler

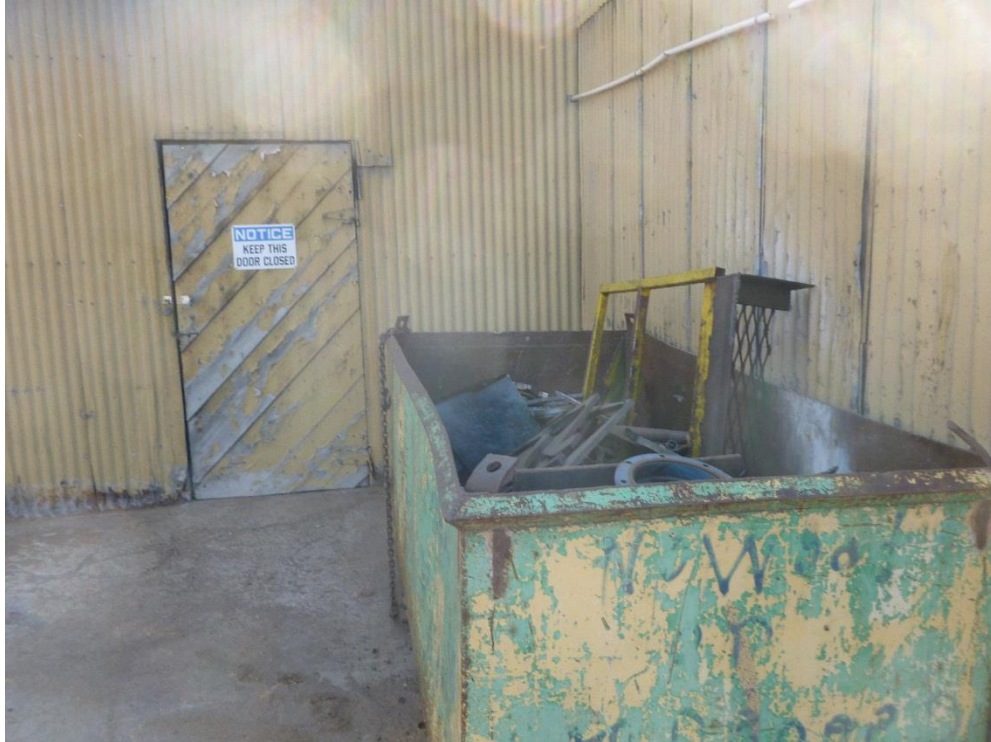
Around the exterior of the machine shop, I observed open dumpsters containing scrap metal (**Photo 15**) and a broken fluorescent lamp (**Photo 16**). Mr. Epperson said that waste fluorescent lamps are typically stored in the electrical room and then taken to a recycling company.

Photo 15 / P1020708 – Open scrap metal dumpster located outside the machine shop

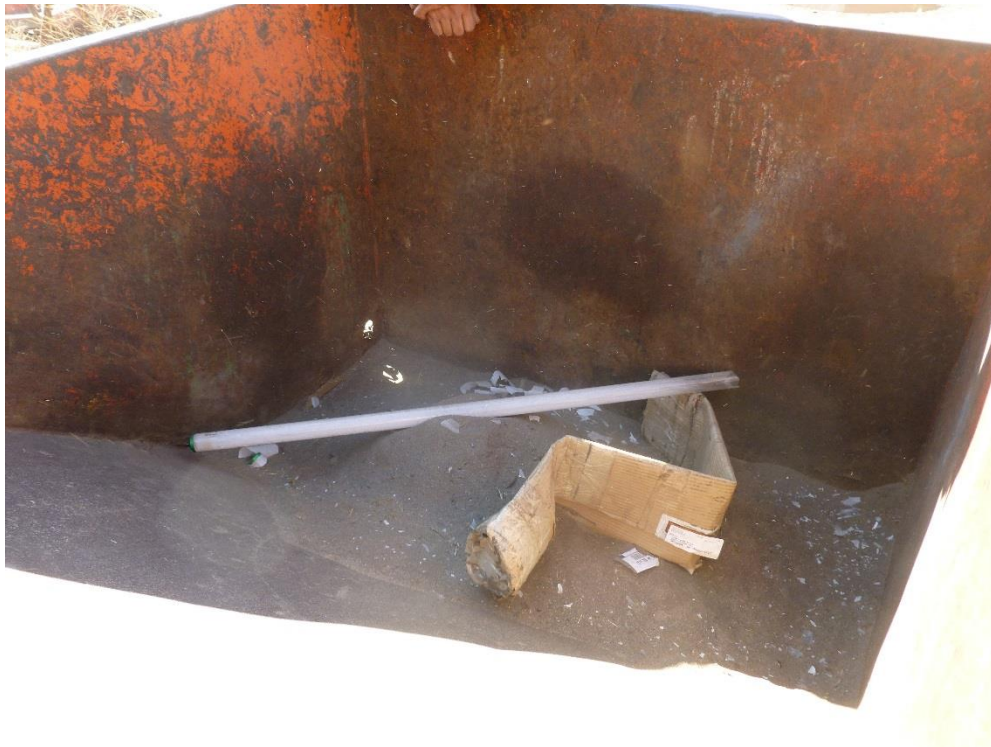
Photo 16 / P1020701 – View inside an open dumpster containing a broken fluorescent lamp located outside the machine shop.

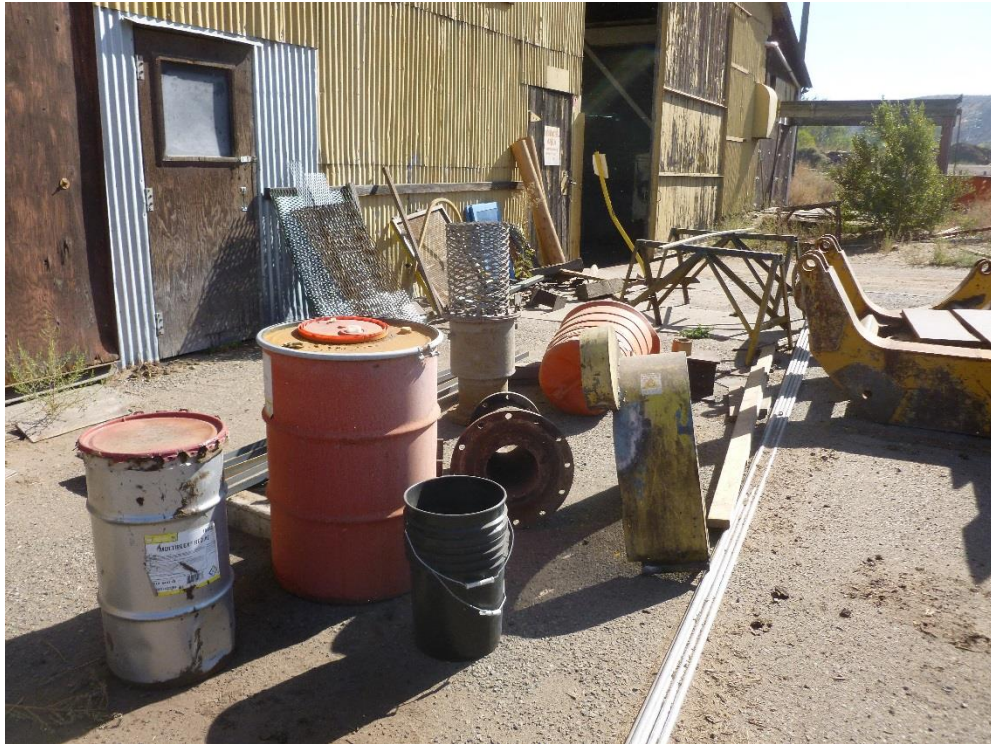
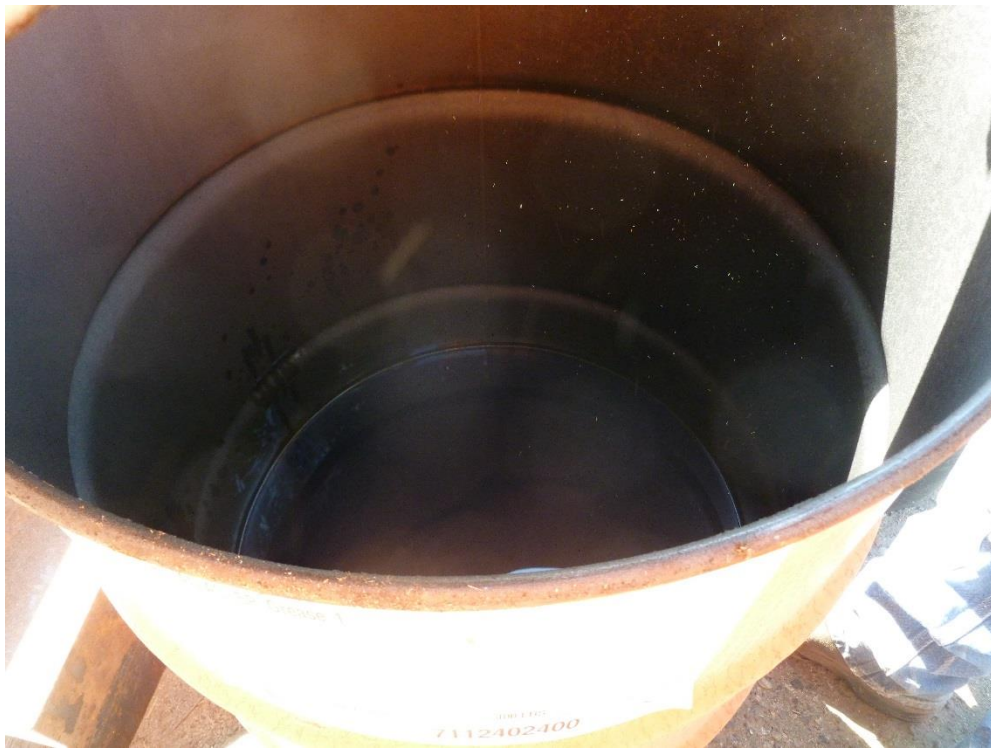
Outside the machine shop, I observed multiple containers (**Photo 17**), including an orange drum, which contained parts washer solvent, according to Mr. Epperson. I noted that the metal ring was not bolted to secure the lid on this drum. Mr. Epperson lifted the lid and I observed fluid inside the drum (**Photo 18**). In this area, I also observed an open bucket of oil (**Photo 19**) on the ground. Mr. Epperson said he did not know why the solvent drum and oil bucket were stored outside. He placed the bucket of oil inside the machine shop. Mr. Epperson said that Whitley Fuel picks up used oil from the facility and Safety Kleen services the facility's parts washers.

- A drum of parts washer solvent located outside the machine shop (**Photos 17-18**). I noted that the metal ring of the drum was not bolted to secure the lid of the drum.

Photo 17 / P1020707 – Materials stored outside the machine shop, including an orange drum of parts washer solvent

Photo 18 / P1020706 – View inside a drum containing parts washer solvent located outside the machine shop

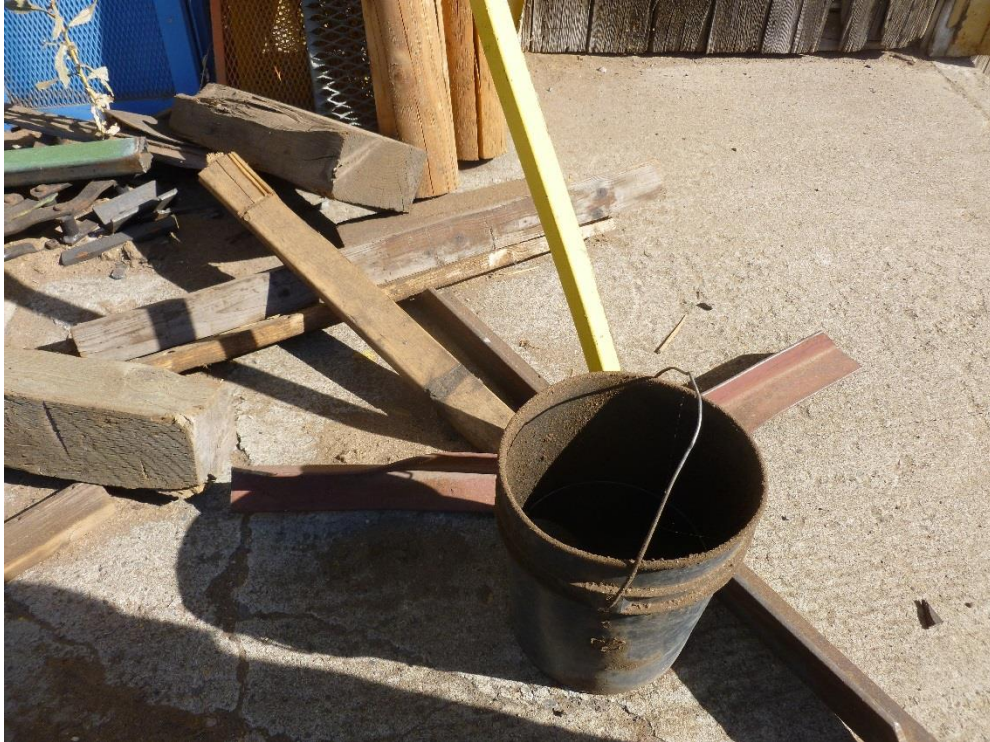
Photo 19 / P1020702 – An open bucket of oil located outside the machine shop

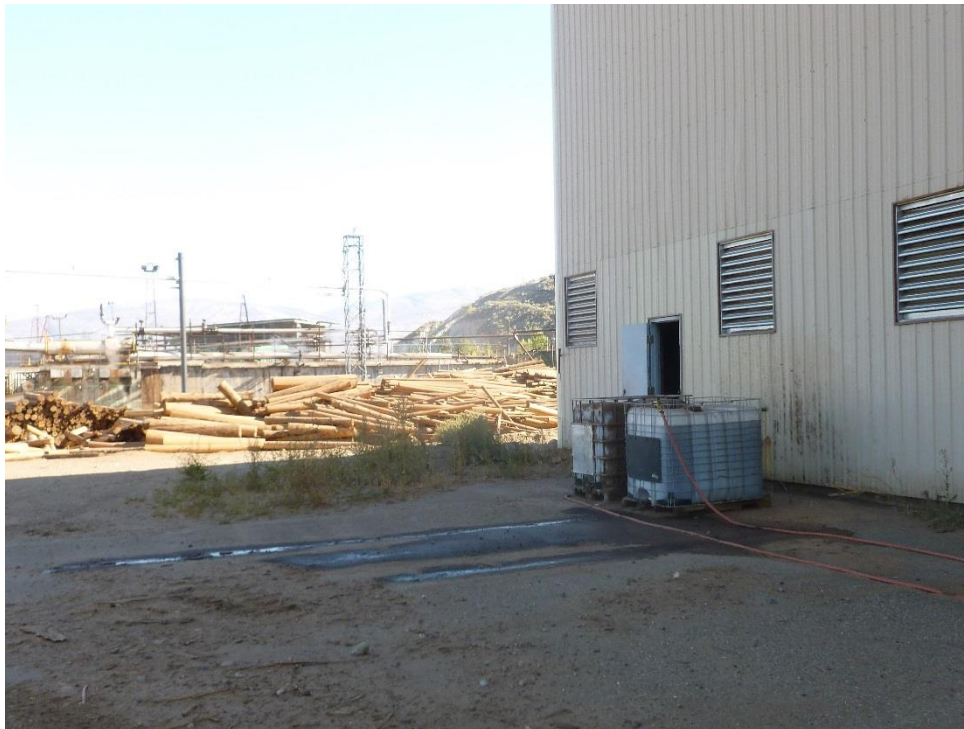
Outside the boiler building, I observed totes of dark fluid, which Mr. Epperson identified as compressor oil (**Photo 20**). He said that the totes had been left behind by the tribe and have been located in this area since before he started working at the facility approximately two years ago. It was not clear whether this oil was a waste or a product. Outside the log vat building, I also

Photo 20 / P1020687 – Totes of dark fluid located outside the boiler building. This is a cropped version of the original photograph.

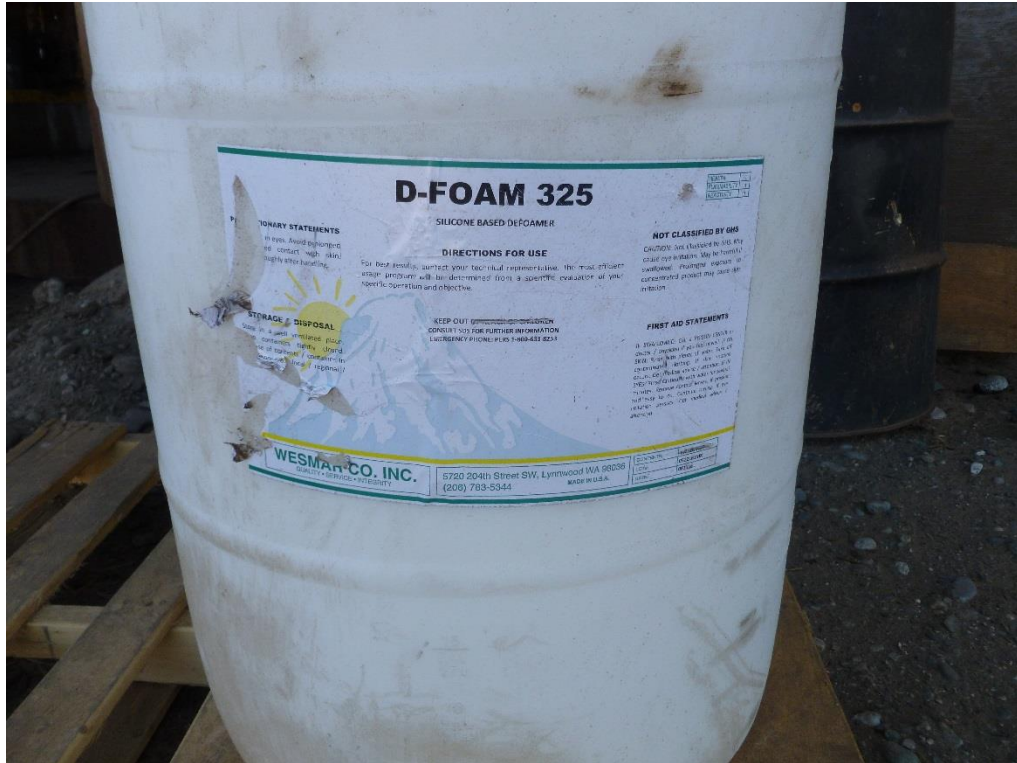
observed a drum of defoamer, labeled as D-FOAM 325 (**Photo 21**) and additional totes of dark fluid (**Photo 22**). Mr. Epperson said that he was not familiar with these totes, because they had been placed there while he was on vacation the previous week. He speculated that these totes contained gear oil. It was not clear whether this oil was a waste or a product. In this area, I also inspected the concrete tank that contained hot liquid used to steam the log vats. I noted that the walls of this tank were cracked and stained (**Photo 23**). Mr. Epperson said that the hot liquid consisted of a mixture of water and defoamer.

Photo 21 / P1020678 – A drum of defoamer (D-FOAM 325) stored outside the log vat building

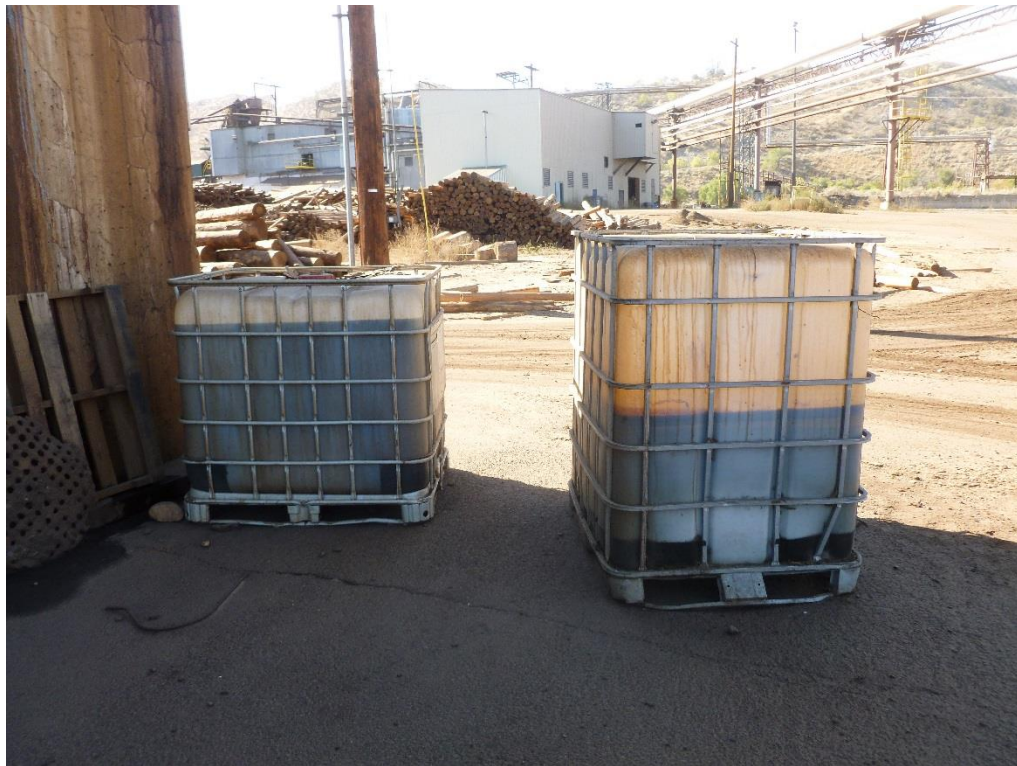
Photo 22 / P1020677 – Totes of dark fluid stored outside the log vat building

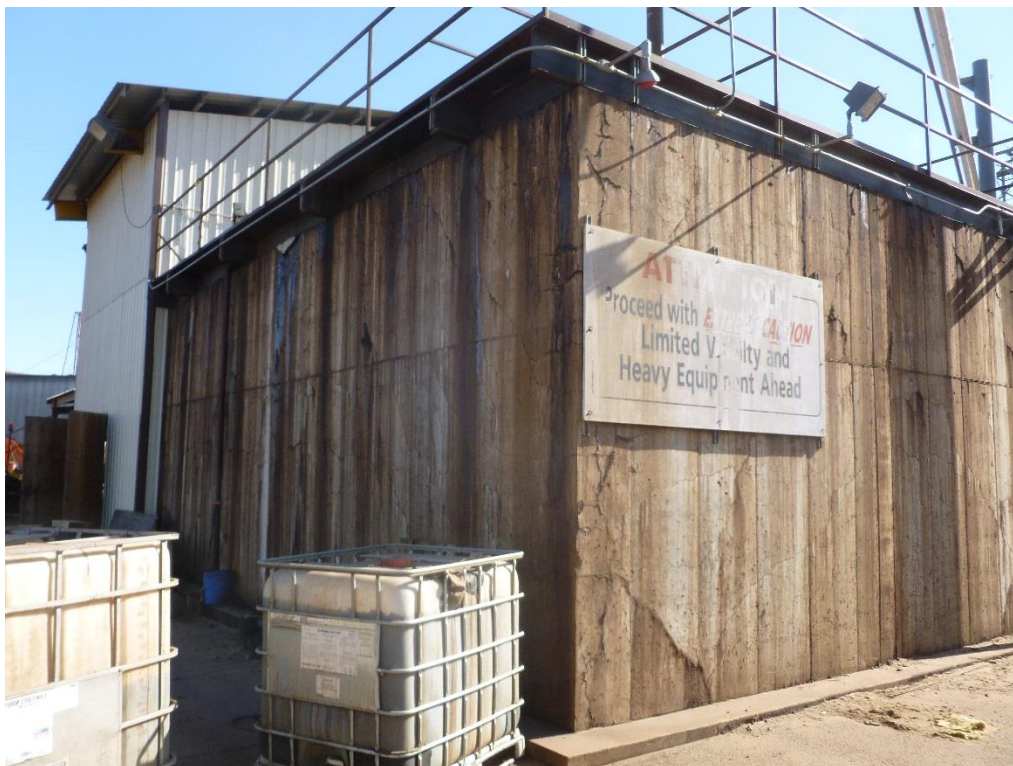
- I inspected the concrete tank (**Photo 23**) of hot liquid used to steam the log vats. I noted that the walls of this tank were cracked and stained and that moisture was visible on portions of the tank exterior. Mr. Epperson said that the hot liquid consisted of a mixture of recirculated log vat water and defoamer (**Photo 21**).

I also inspected the concrete tank that contained hot liquid used to steam the log vats. I noted that the walls of this tank were cracked and stained (**Photo 23**) and that moisture was visible on portions of the tank exterior. Mr. Epperson said that the hot liquid consisted of a mixture of recirculated log vat water and defoamer (**Photo 21**). I noted that a tank failure could cause this process water to contaminate stormwater in this area.

Photo 23 / P1020679 – Northeasterly view of the log vat sprinkler tank. A tote of dark fluid appears in the foreground. Moisture is visible on the left side of the tank.

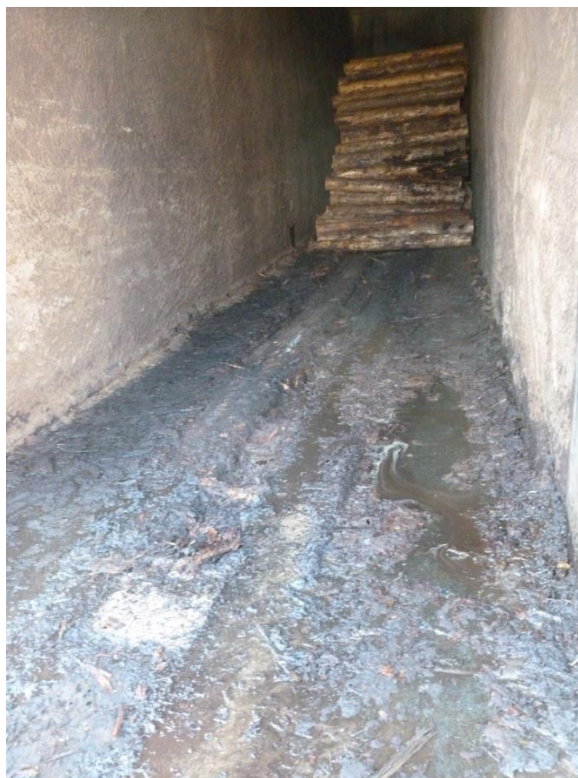
- I inspected the log vats (**Photo 24**) used to prepare logs for peeling. Mr. Epperson said that log vat fluid seeps out through the bottom of the vat doors and into a small exterior concrete trench that channels fluid to a sump (**Photo 25**) prior to reuse. I noted that the small trench is exposed to stormwater and may have the potential to overflow during a storm event. Mr. Epperson also said that the trench only extends far enough to collect escaped fluid from vats 4 through 11. Any fluid that escapes vats 1-3 is released to the ground, where it is exposed to stormwater. Mr. Epperson said that the facility had tentative plans to extend the trench to vats 1-3 during the next boiler shutdown, which was scheduled for October 2016.

Photo 24 / P1020669 – View inside log vat 9

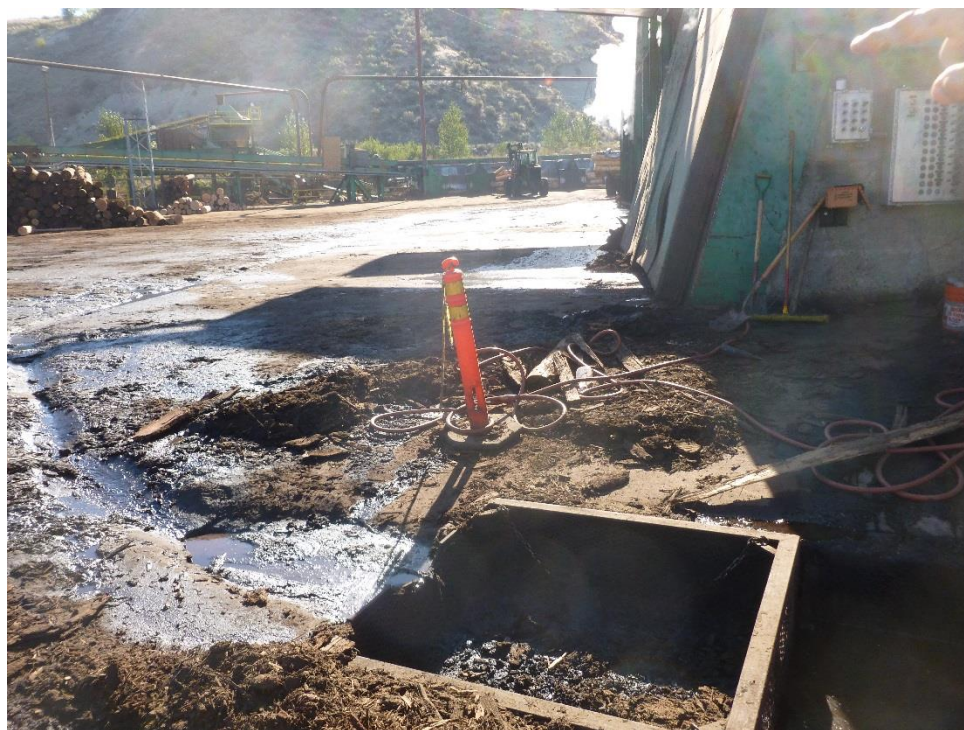
Photo 25 / P1020667 – Recirculation trench and sump that collects flow from vats 4 through 11

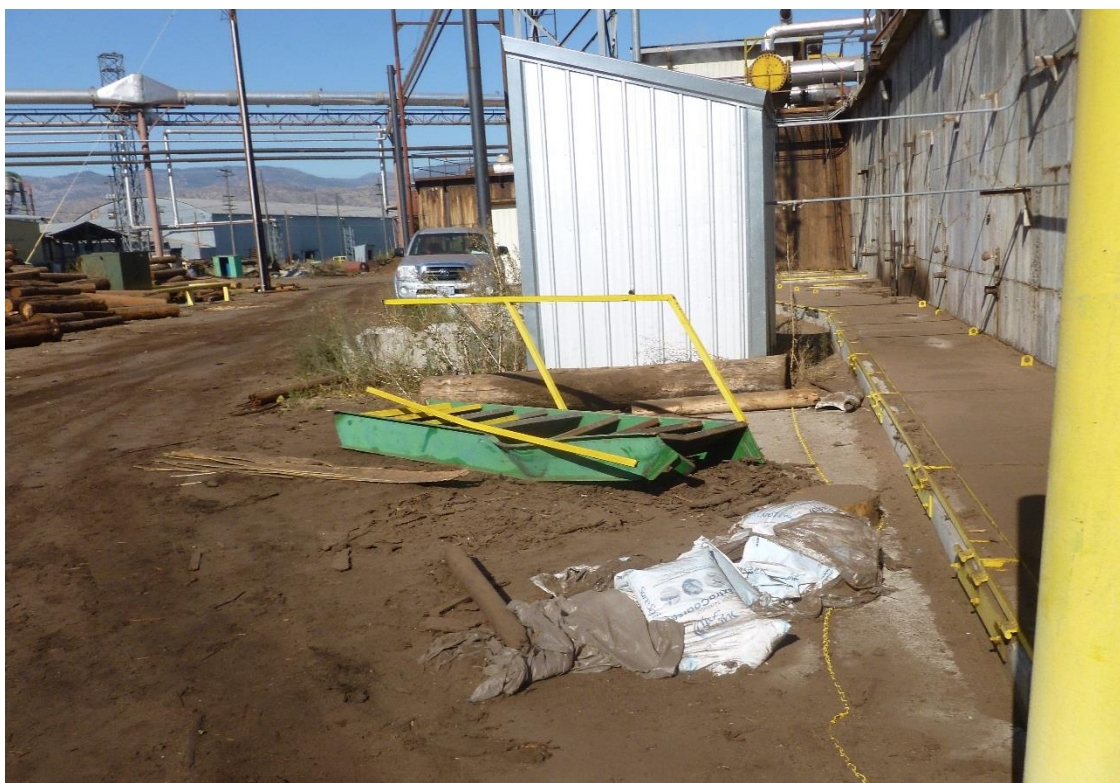
On the south side of the log vat building, I observed bags of salt on the ground (**Photo 26**). To the west of the log vat building, I observed piles of wood debris (**Photo 27**), which the facility uses as hog fuel, and piles of wood chips (**Photo 27**), which are sold to other companies. Mr. Epperson said that wood chips are collected in bins for pick-up, but the bins were full at the time of the inspection, so the excess wood chips were being stored in piles on the ground.

Photo 26 / P1020683 – Bags of salt on the ground on the south side of the log vat building. This is a cropped version of the original photograph.

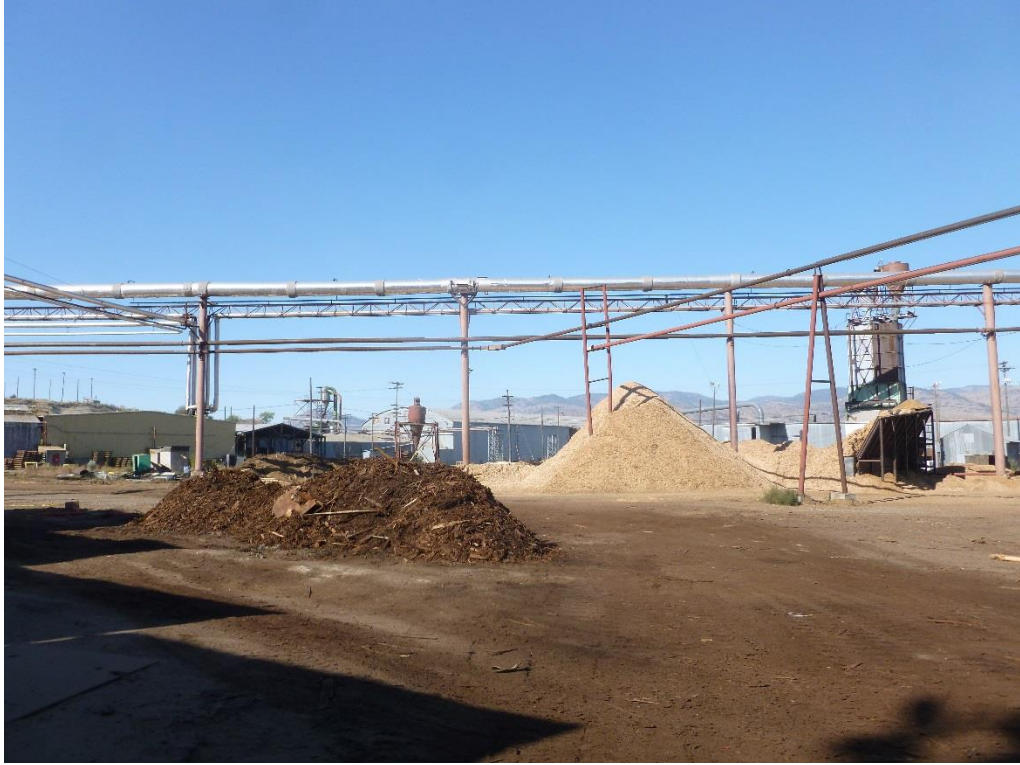
Photo 27 / P1020672 – Piles of wood chips and hog fuel located on the west side of the facility

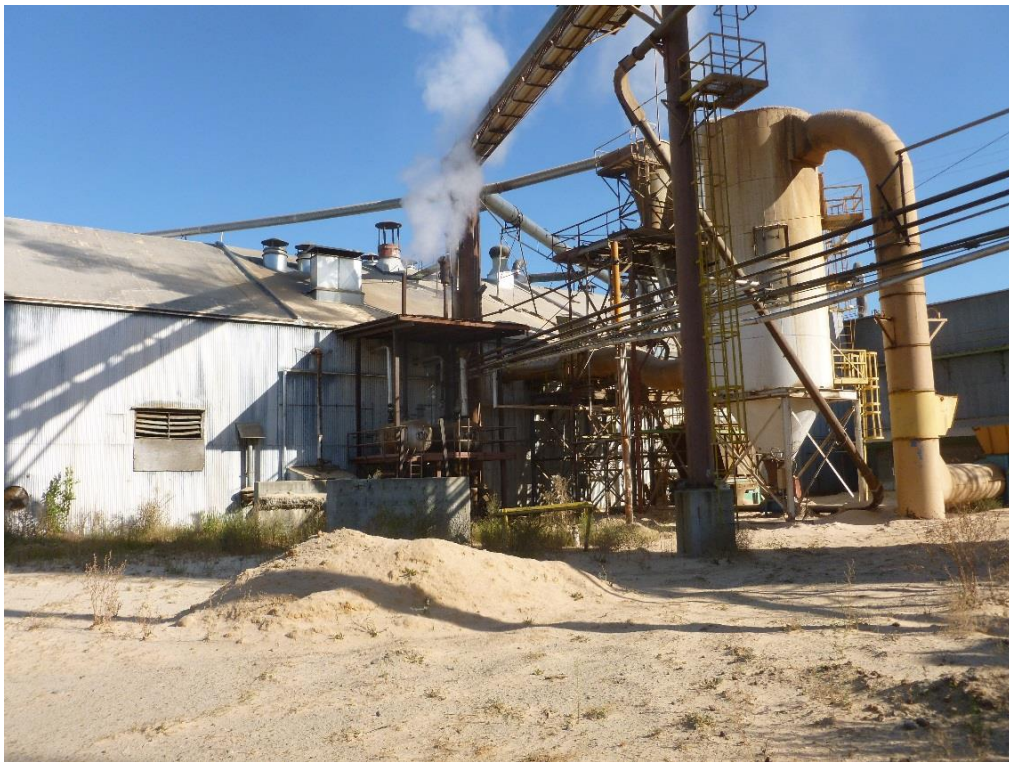
I inspected the bag house and steam vent on the south side of the plywood plant (**Photo 28**). Mr. Epperson said that the bag house collects dust from the sander in the plywood plant. Sawdust is then mixed with hog fuel for use in the boiler. In this area, I observed sawdust and steam condensate on the ground (**Photo 29**). Mr. Epperson said that the plywood plant was equipped with tanks and pumps to contain steam condensate, but the pumps were leaking at the time of the inspection.

- I inspected the tanks and pumps (**Photo 28**) used to control steam condensate from the plywood plant. Mr. Epperson said that the pumps were leaking and I observed steam condensate on the ground (**Photo 29**).

I inspected the bag house that collects dust from the sander in the plywood plant. In this area, I observed accumulated dust at the base of the exterior baghouse (**Photo 28**).

I inspected the tanks and pumps used to collect and control steam condensate on the south side of the plywood plant (**Photo 28**). Mr. Epperson said that the pumps were leaking and I observed steam condensate on the ground (**Photo 29**) with exposure to stormwater.

Photo 28 / P1020665 – Bag house (right) and steam vent (left) on the south side of the plywood plant. Steam condensate is controlled by tanks and pumps that appear under the vent pipes.
